# THE IMPORTANCE OF INSPECTIONS ON ELECTRICAL INSTALLATIONS IN HAZARDOUS LOCATIONS

Copyright Material IEEE  
Paper No. PCIC-

**Abstract** – Electrical installations in hazardous locations (classified areas) need careful attention because non-conformities can bring considerable risks not only to the site, but also for other industries and residential areas nearby. To assure safe operation of an industrial facility it is necessary not only that all electrical and electronic equipment to be used in hazardous locations is correctly specified and purchased (known as “Ex equipment”), but also properly installed and maintained. The discussion in this paper is largely based upon International Electrotechnical Commission (IEC) standards; however, conceptually the same philosophy applies to American based standards and installations as well.

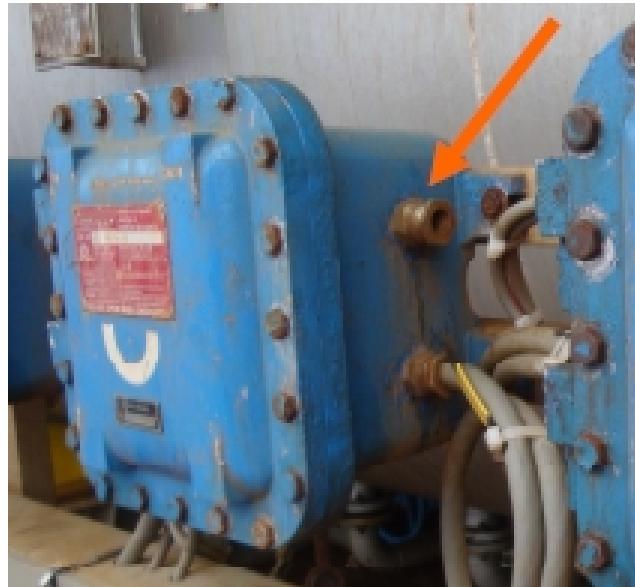
2) Lack of blanking elements in unused openings: On Ex d enclosures, unused openings need to be closed with certified blanking elements to keep the integrity of the enclosure if an internal explosion occurs.

Figs. 2 and 3 illustrate these non-conformities.

Fig. 2 A cable gland cannot replace a listed metal close-up plug to close an unused opening of an Ex d enclosure.

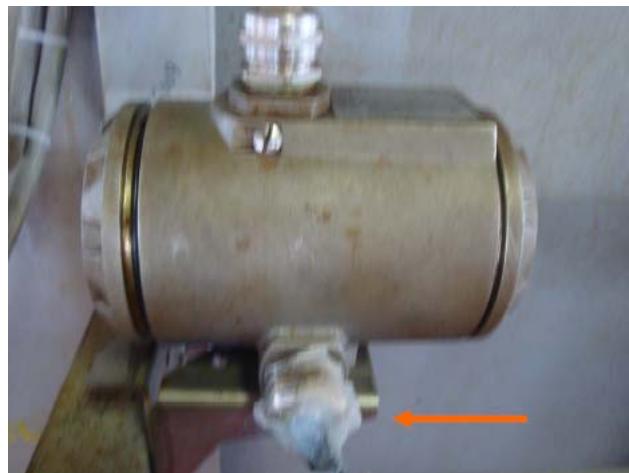
Fig. 3 An unused cable entry of an Ex d instrument was closed with a room temperature vulcanized (RTV) silicone sealant instead of a certified metal close-up plug.

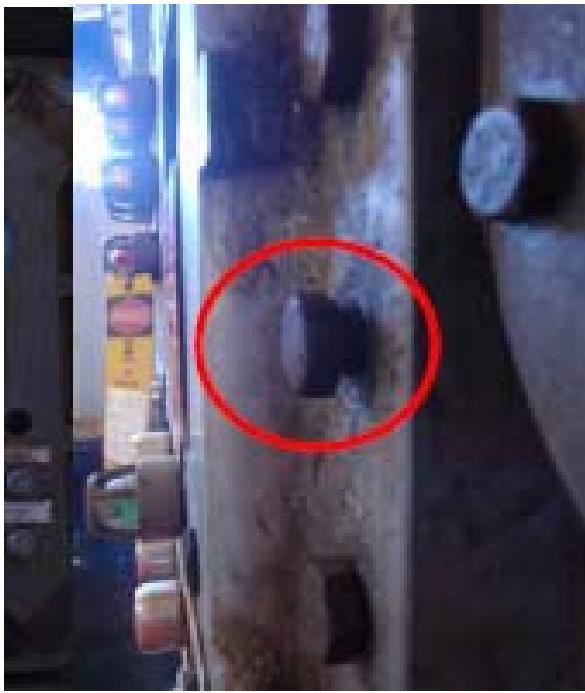
3) Inadequate screws' tightening – On Ex d enclosures, this non-conformity compromises the Ex-d integrity [3]. The Figs. 4 and 5 illustrate this non-conformity.

Fig. 4 Loose screws of an Ex d enclosure.

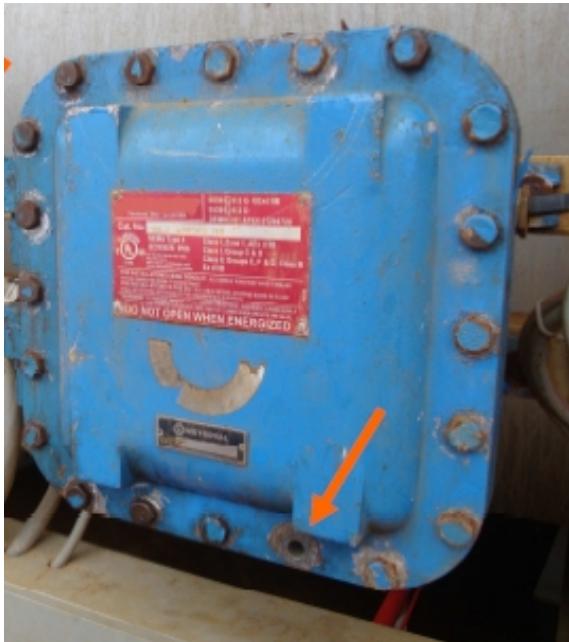
Fig. 5 A screw was missed.

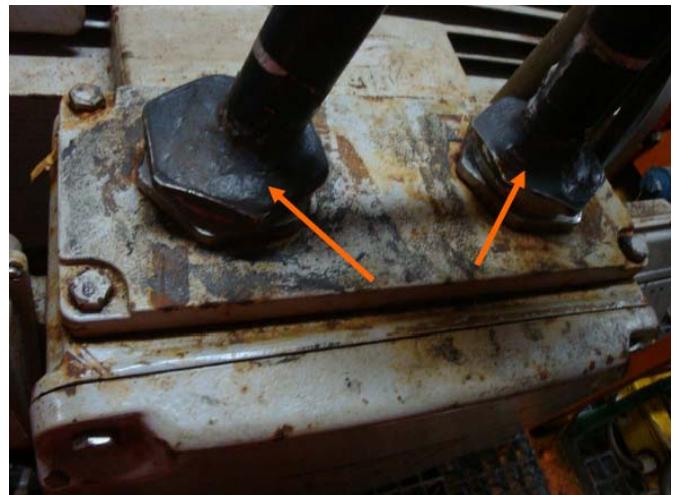
4) Improper assembly of cable glands – Certified cable glands must be selected considering the external cable's diameter, and on Ex e enclosures they are very important to avoid the ingress of water and dust into the enclosure.

The Figs. 6 and 7 illustrate non-conformities related with improper installation of cable glands [1].

Fig. 6 Cable-glands incorrectly “filled” with silicone sealant on an Ex e enclosure.

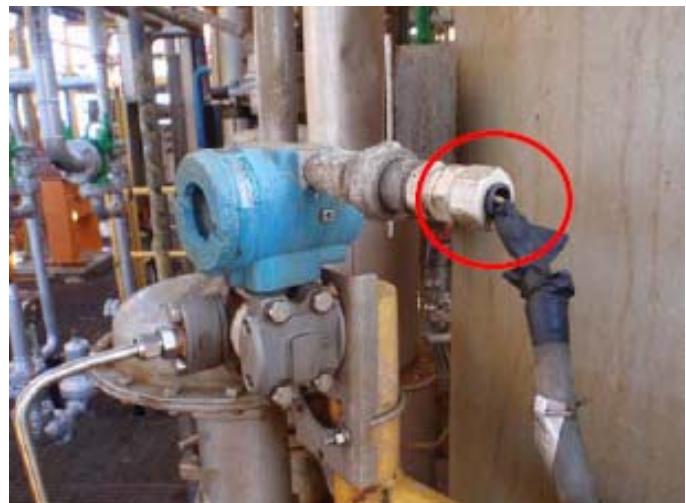
Fig. 7 Cable gland incorrectly “filled” with electrical insulating tape.

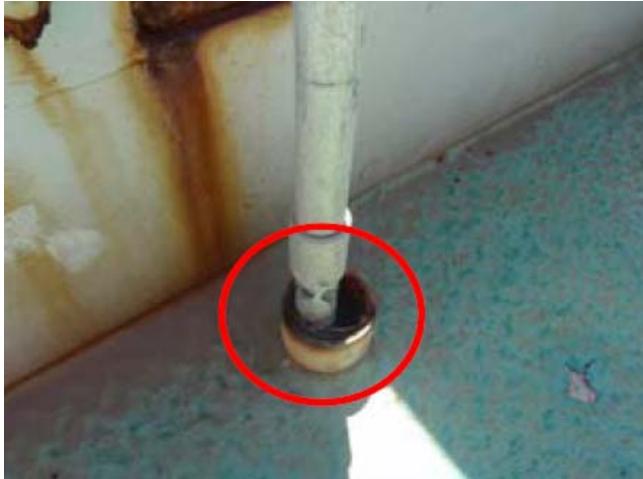
5) Piping penetration without sealing: when the conduits cross different floors with different area classifications, they must be sealed, in order to avoid the gas passage between adjacent hazardous locations.

Fig. 8 shows a hole in the floor which interconnects a hazardous area to a non-hazardous one, where the proper sealing compound was missed.

Fig. 8 Floor penetration without a sealing compound.

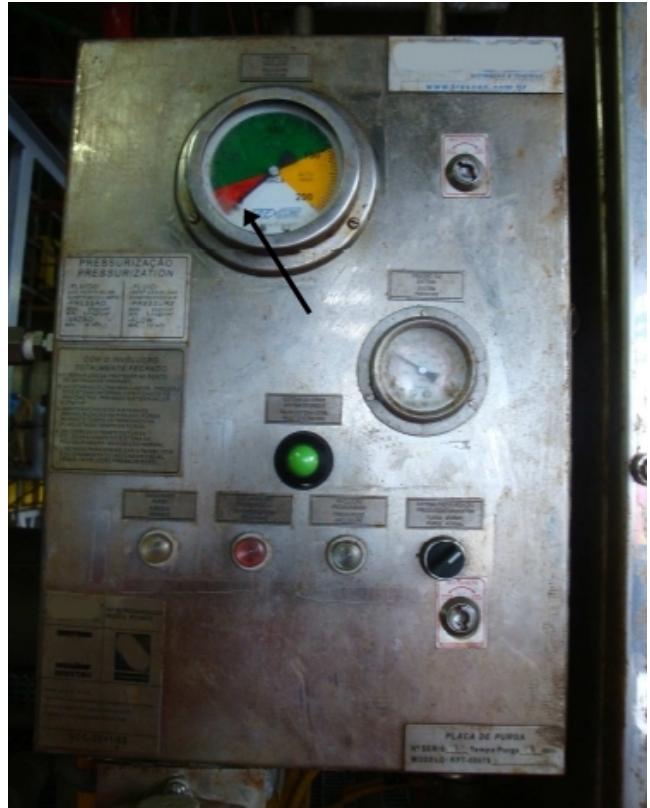
6) Pressurization failure on Ex-p equipment: the integrity of pressurized equipment is effective only when the internal pressure is adjusted within the range recommended by the manufacturer, in order to prevent the ingress of flammable gas. So, leaks can reduce internal pressure and compromise the Ex p equipment integrity.

Excessive pressure can also bring negative consequences to the Ex p enclosure as tensile on hinges and doors bulging.

Fig. 10 illustrates an internal pressure indicator, showing no pressurization inside the Ex p enclosure in a Zone 1 location.

Fig. 10 Underpressure indication in an Ex-p enclosure

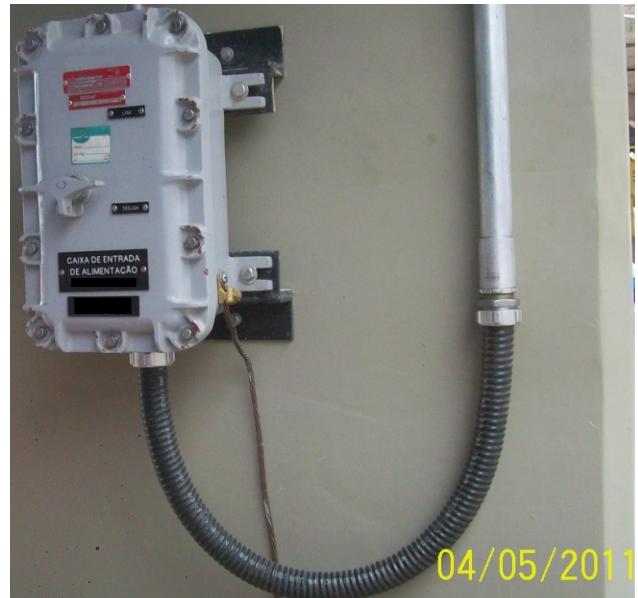
7) No conduit sealing fittings: Close to flameproof enclosures it is necessary to install a certified conduit sealing device with the proper sealing compound in order to avoid the "pressure pilling" through the conduit, if an internal explosion occurs [3, 4]. Fig. 11 illustrates a non-conformity of the missing conduit sealing device.

Fig. 11 A plastic flexible conduit connected to an Ex-p enclosure without a conduit sealing device.
